# **BCRC REPORT OF FIELD FIRE TEST**

17 July 2019

Live fire exposure test on AHMC rendered and un-rendered wall

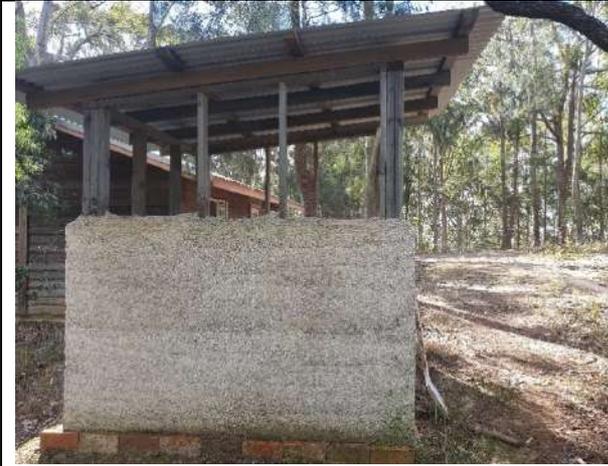
Photo 1: un-rendered wall

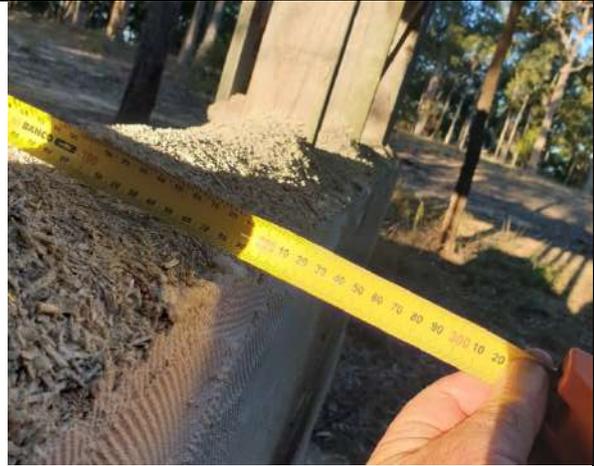
Photo 2: wall 200mm thick

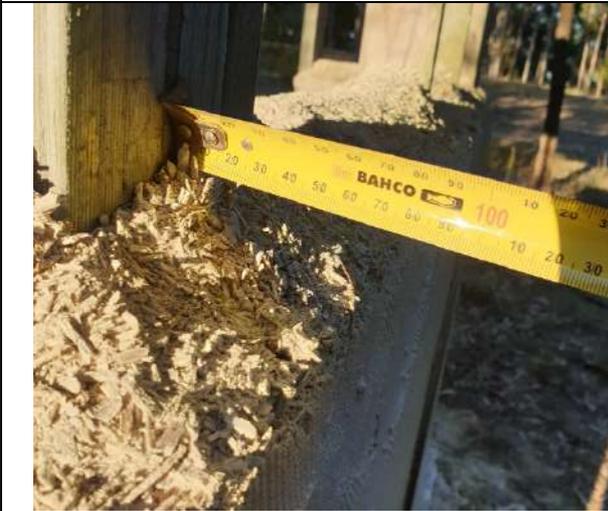
Photo 3: Cover to studs shown as 65mm

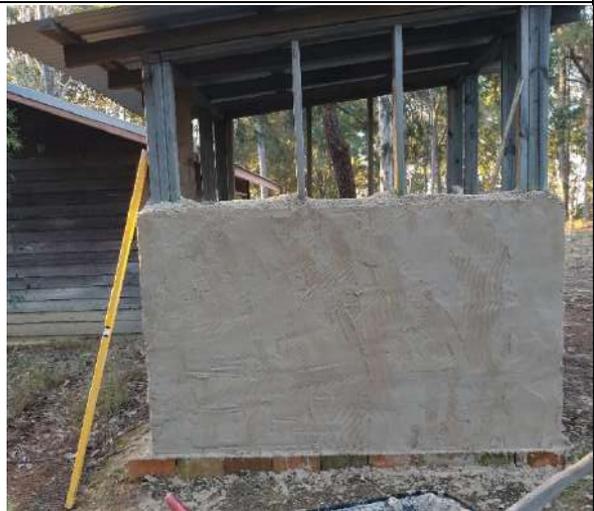
Photo 4: Rough rendered wall

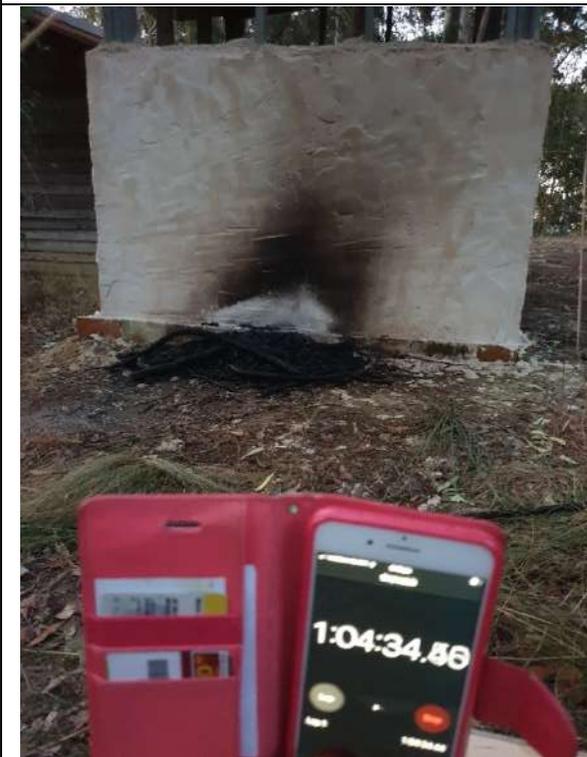
Photo 27: Fire out 1 hour 4 min test over

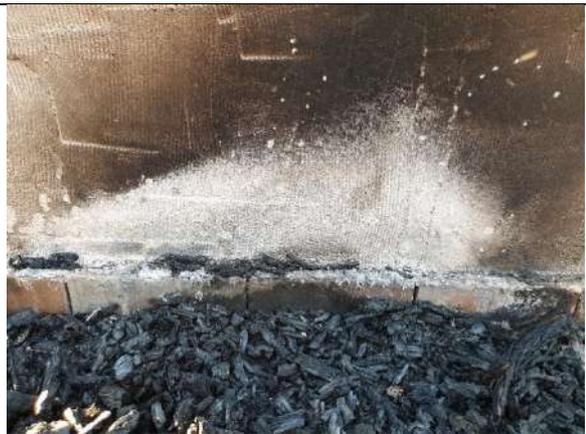
Photo 28: Close up of sound render after fire had cooled down

At the conclusion of the test, the render was tested for drumminess, the render was sound and appeared to be fully adhered to the hempcrete substrate. Some faint hair line cracks were visible on the surface of the render.

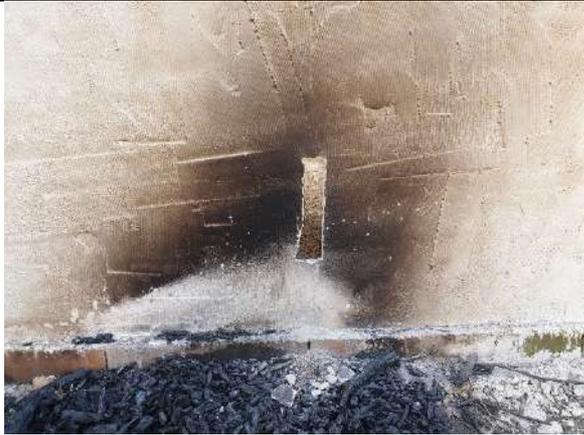
Photo 29: Site of investigation into the effect of the fire of the hempcrete located at the centre of the fire affected area

A section of the render was removed for further investigation. The location of the investigation is shown in Photo 29. The render was sound though it had been softened by the effects of the fire.

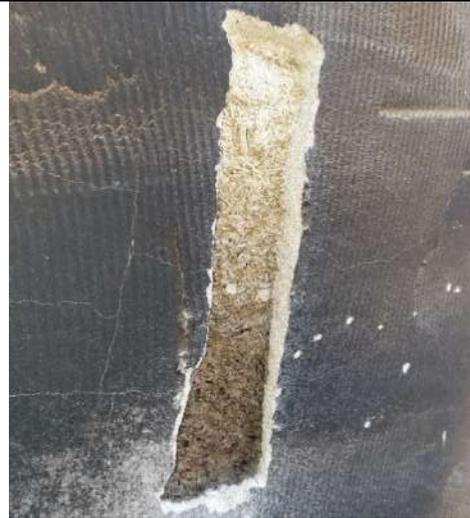
Photo 30: Condition of hempcrete beneath the render. The render thickness was 6mm at the bottom and 12mm at the top of the cut. The colour and consistency of the underlying hempcrete was not altered where the thickness of the render exceeded 9mm. with a thinner render layer some discolouration was evident

Photo 30 shows a close-up of the hempcrete beneath the render and shows the thickness of the render. The render thickness varied from 6mm at the bottom to 12 mm at the top. It was found, and this is visible in the photo, that where the render was more than 9mm thick, the hemp was not discoloured at all and had not been affected by the fire exposure. Where the render thickness was between 6 to 9mm the colour of hempcrete substrate altered by the heat transferred through the render. The depth of the charring was limited to 2-3mm.
